Tibial Plateau Fractures

Alan M. Reznik, M.D., MBA

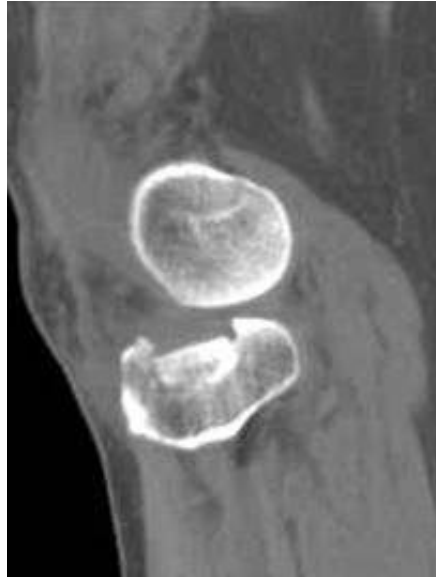
A Coronal and Sagittal CT Scan images of a Tibial Plateau Fracture (Below): This reconstructed image (made of many images reformatted by the computer) shows a lateral compression fracture through the lateral tibial plateau. The goal of treatment is to restore the height of the depressed fragment seen here.

Front view of laterally compressed fracture

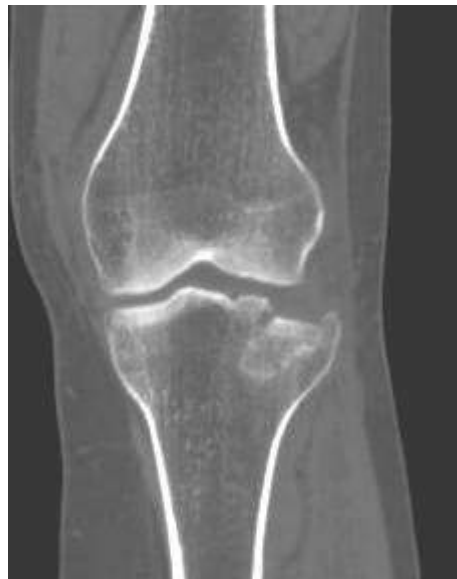
Side, sagittal, view of the same fracture

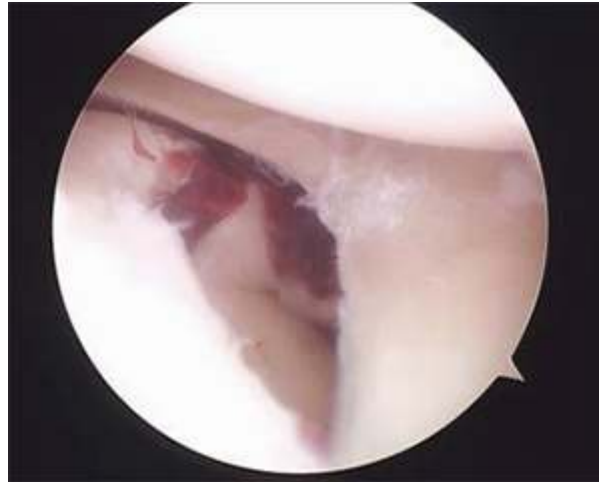
Arthroscopic view of the same fracture

Note how the depressed tibial plateau is no longer supporting the lateral meniscus. This explains the lateral knee instability.

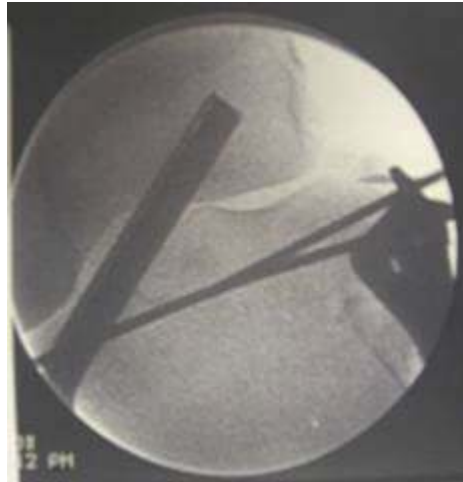
Intra-operative X-ray of the scope in place and a trial positioning of the plate with the bone elevated to its normal height.

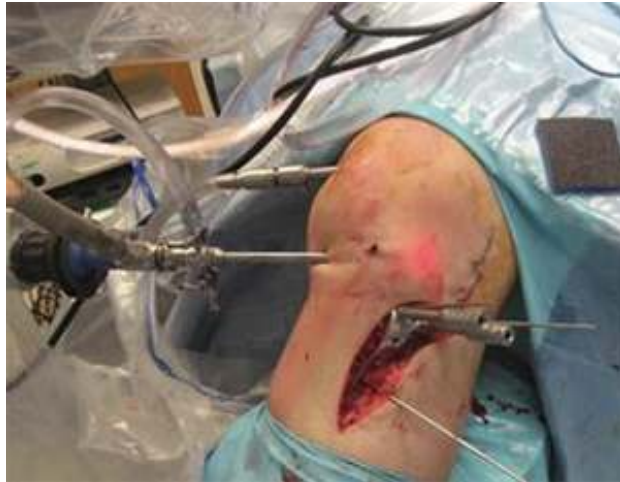
The plate is being placed in position, with the scope inside the knee checking the reduction. The fracture and the plate are being held with temporary pins before the screws are placed.

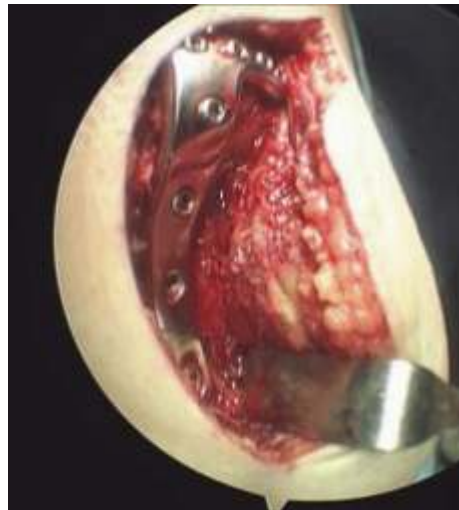
Side view of the plate in place

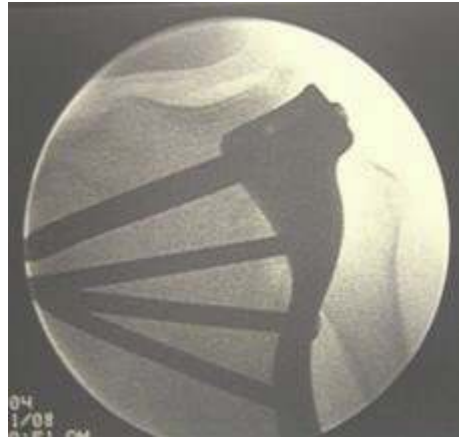
Final view of the fracture reduced, the bone graft in place and the plate affixed to the bone with the locking screws to fully stabilize the fracture.

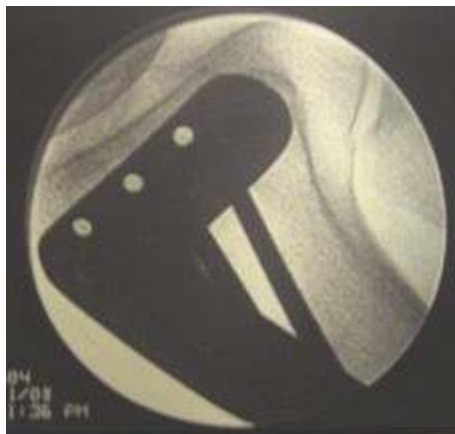
This is the final position of the plate in place with eight screws, as seen through the lateral "lazy S" incision. Four screws are holding the tibial plateau surface up; four are fixing the plate to the shaft of the tibia and the medial side of the knee.
